Annual Inspection

Osgathorpe Parish Council

Thomas Harley Play Area

Inspection Ref: 2094570

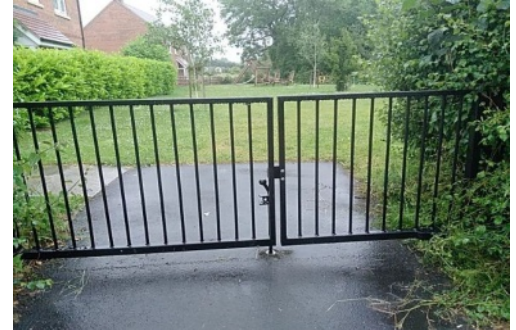
Item: Gate - Combination
Manufacturer: I.A.E. Fencing
Surface Type: Tarmac
Item Quantity: 1
Equipment Compliance: N/A
Surface Area Compliance: Yes

This item is satisfactory - no work required -

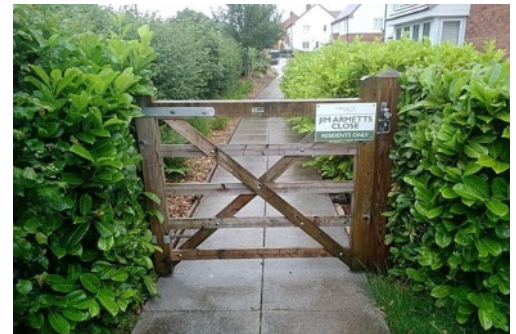
Item: Gate - Pedestrian
Manufacturer: Unknown
Surface Type: Paving Slabs
Item Quantity: 1
Equipment Compliance: N/A
Surface Area Compliance: Yes

This item is satisfactory - no work required -

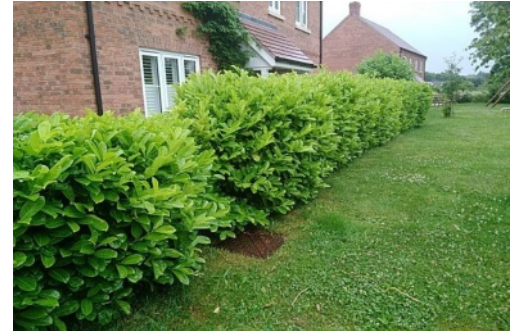
Item: Hedge
Manufacturer: Natural Feature
Surface Type: Grass
Item Quantity: 1
Equipment Compliance: N/A
Surface Area Compliance: N/A

This item is satisfactory - no work required -

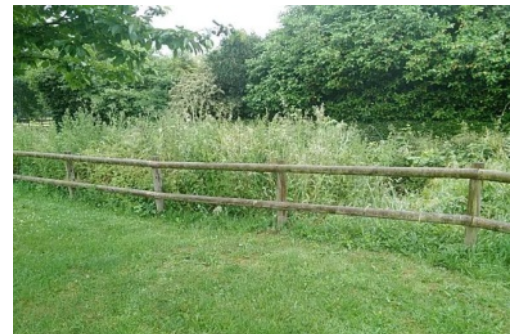
Item: Fencing - Post & Rail
Manufacturer: Unknown
Surface Type: Grass
Item Quantity: 1
Equipment Compliance: N/A
Surface Area Compliance: N/A

This item is satisfactory - no work required -

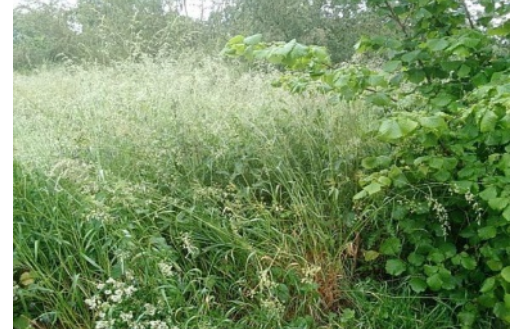
Item: Fence - Timber & Mesh Infill
Manufacturer: Unknown
Surface Type: Grass
Item Quantity: 1
Equipment Compliance: N/A
Surface Area Compliance: N/A

This item is satisfactory - no work required -

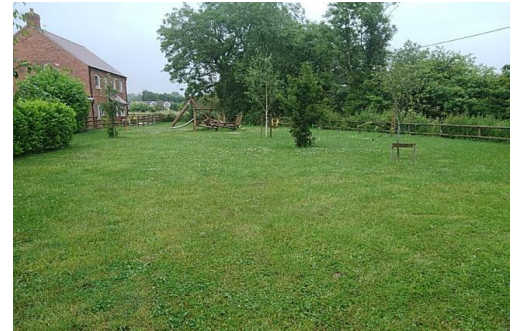
Item: Playground Sign
Manufacturer: Not Applicable
Surface Type: N/A
Item Quantity: 1
Equipment Compliance: N/A
Surface Area Compliance: N/A

It is recommended that signage, with information including the site address, contact information for maintenance issues and emergency contact details are provided for the facility - Provide in accordance with the recommendations

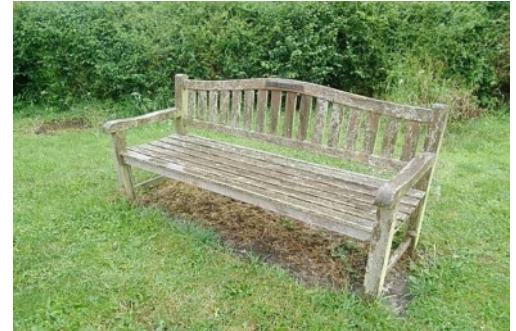
Item: Seat
Manufacturer: Unknown
Surface Type: Grass
Item Quantity: 1
Equipment Compliance: N/A
Surface Area Compliance: Yes

This item is satisfactory - no work required -

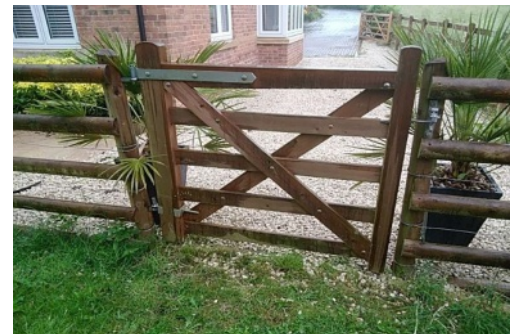
Item: Gate - Pedestrian
Manufacturer: Unknown
Surface Type: Mixed Surface
Item Quantity: 1
Equipment Compliance: N/A
Surface Area Compliance: Yes

This item is satisfactory - no work required -

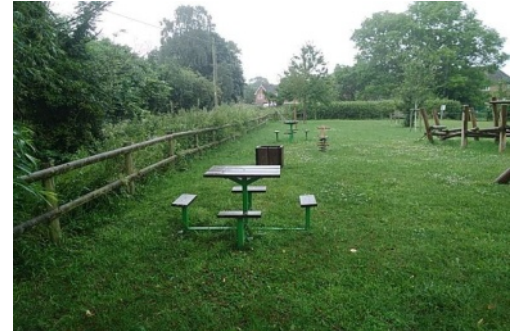
Item: Picnic Table
Manufacturer: Wicksteed Playgrounds
Surface Type: Grass
Item Part Number: Windsor Picnic Table
Item Quantity: 2
Equipment Compliance: N/A
Surface Area Compliance: Yes
Total Findings: 1

This item is satisfactory - no work required -

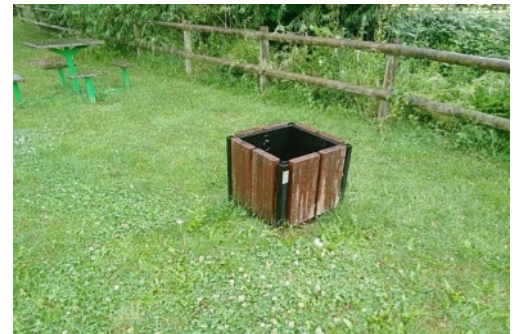
Item: Litter Bin
Manufacturer: Wicksteed Playgrounds
Surface Type: Grass
Item Part Number: Annick Wooden Bin
Item Quantity: 1
Equipment Compliance: N/A
Surface Area Compliance: Yes
Total Findings: 1

This item is satisfactory - no work required -

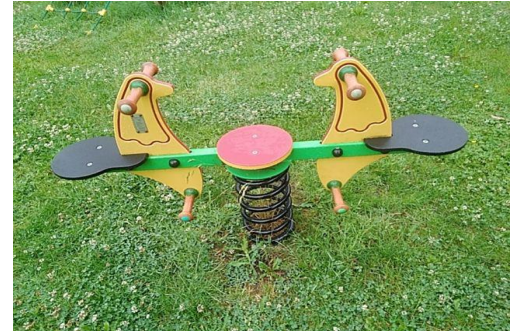
Item: Spring See-Saw
Manufacturer: Wicksteed Playgrounds
Surface Type: Grass Matrix Tiles
Item Part Number: Cockerel Spring Seesaw
Item Quantity: 1
Equipment Compliance: Yes
Surface Area Compliance: Yes
Total Findings: 1

The spring clamps are loose - Tighten all loose fixings

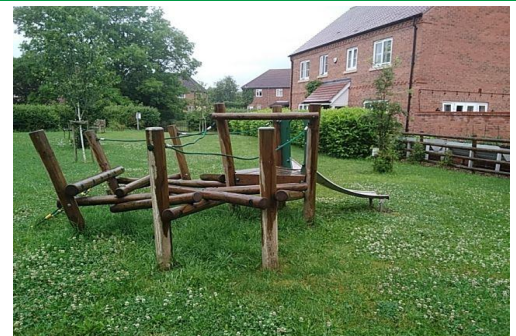
Item: Log Climber
Manufacturer: Wicksteed Playgrounds
Surface Type: Grass Matrix Tiles
Item Quantity: 1
Equipment Compliance: Yes
Surface Area Compliance: Yes

The timber has a number of splits/shakes or air cracks and this may affect the stability or allow water ingress which will accelerate the rotting process - Monitor to ensure the splits do not cross through fixing points of the structure and/or cause any instability

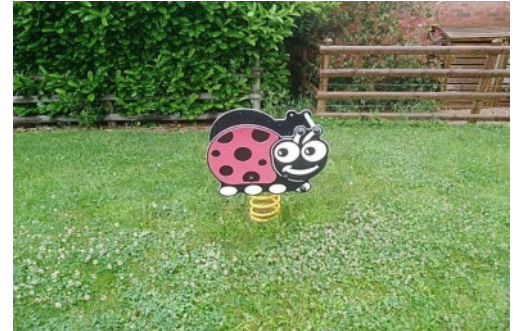
Item: Spring Ladybird
Manufacturer: Wicksteed Playgrounds
Surface Type: Grass Matrix Tiles
Item Quantity: 1
Equipment Compliance: Yes
Surface Area Compliance: Yes

This item is satisfactory - no work required -

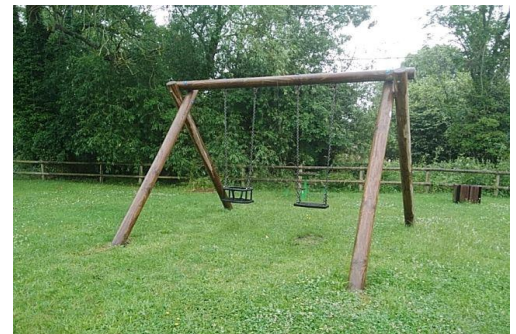
Item: 1 Bay Mixed Seat, 1 Cradle, 1 Flat
Manufacturer: Wicksteed Playgrounds
Surface Type: Grass Matrix Tiles
Item Part Number: 2.3m Timber Swing
Item Quantity: 1
Equipment Compliance: Yes
Surface Area Compliance: Yes
Total Findings: 2

The timber has a number of splits/shakes or air cracks and this may affect the stability or allow water ingress which will accelerate the rotting process - Monitor to ensure the splits do not cross through fixing points of the structure and/or cause any instability

The cradle seat fixing nuts are corroding - Monitor for deterioration and replace when required

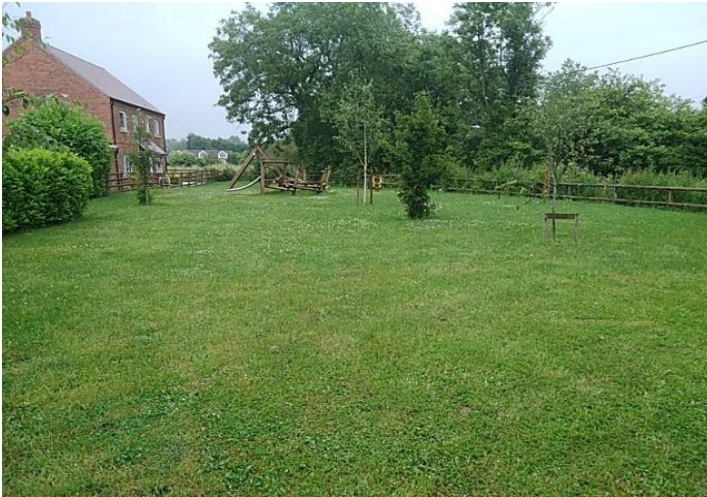
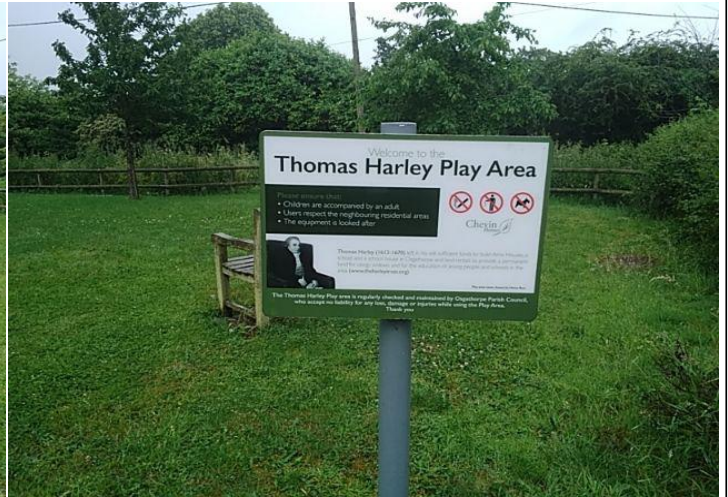
Item: Signs - Playground Sign
Manufacturer: Not Applicable

Finding: It is recommended that signage, with information including the site address, contact information for maintenance issues and emergency contact details are provided for the facility

Action: Provide in accordance with the recommendations

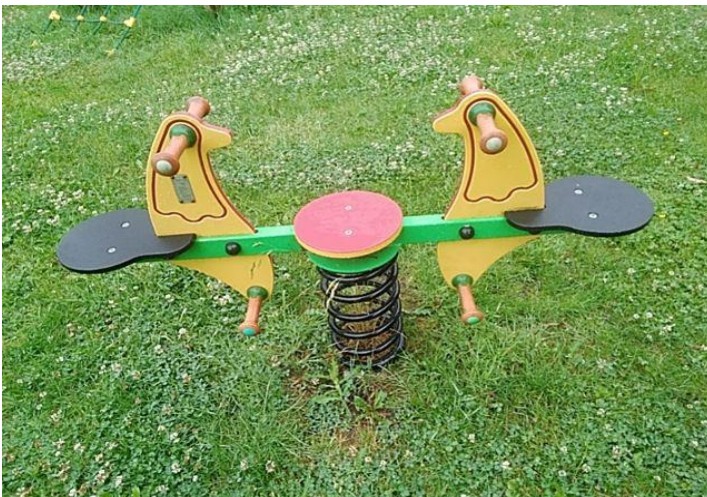
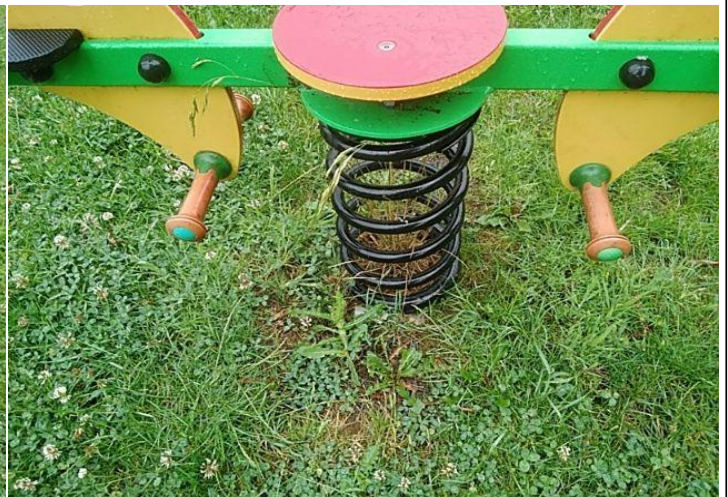
Item: Rocking Equipment - Spring See-Saw
Manufacturer: Wicksteed Playgrounds

Finding: The spring clamps are loose

Action: Tighten all loose fixings

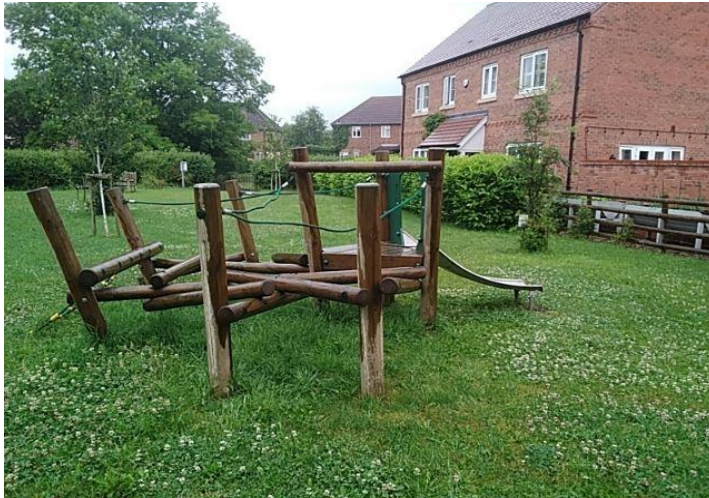
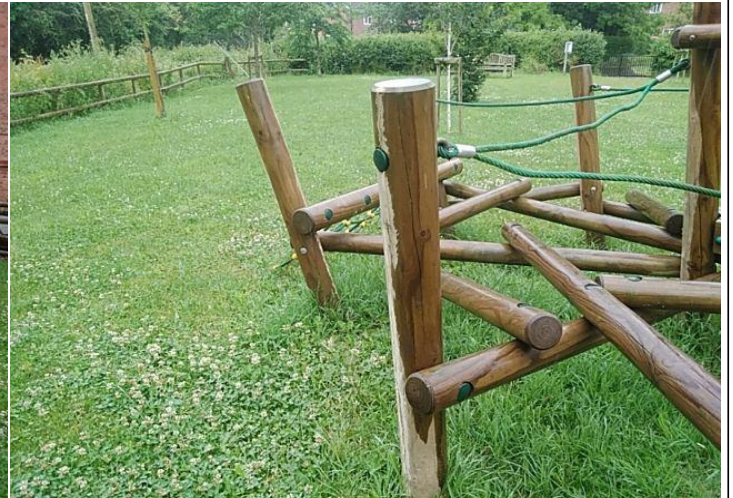
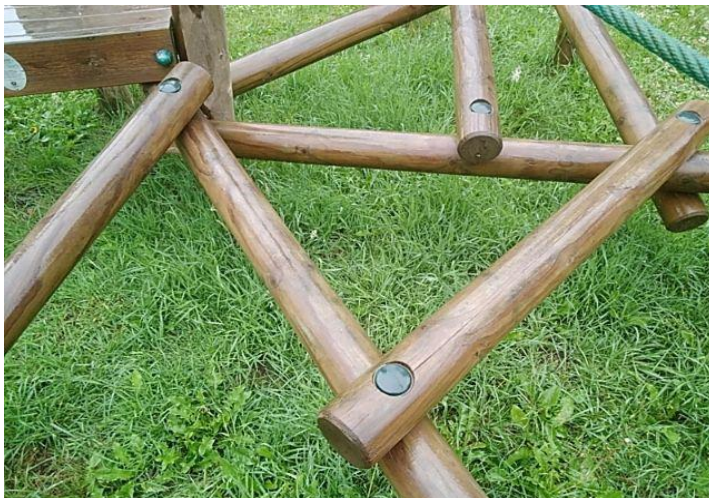
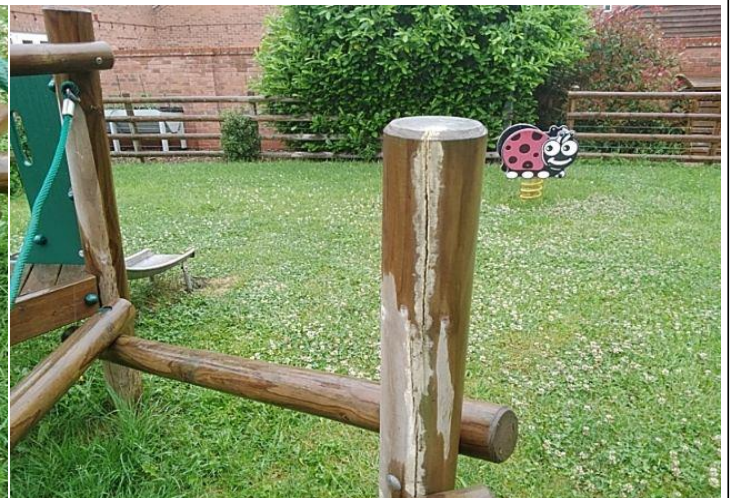
Item: Activity Equipment - Log Climber
Manufacturer: Wicksteed Playgrounds

Finding: The timber has a number of splits/shakes or air cracks and this may affect the stability or allow water ingress which will accelerate the rotting process
Action: Monitor to ensure the splits do not cross through fixing points of the structure and/or cause any instability

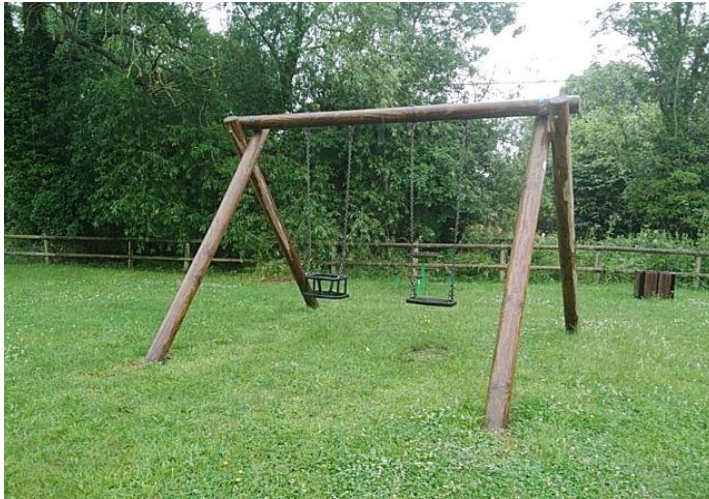
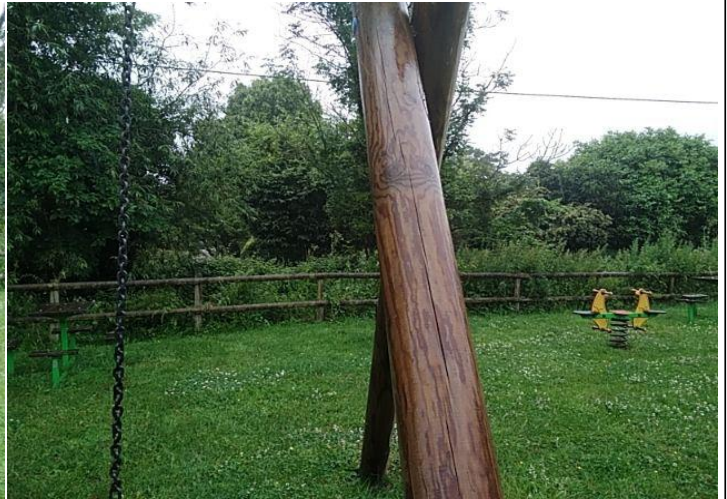
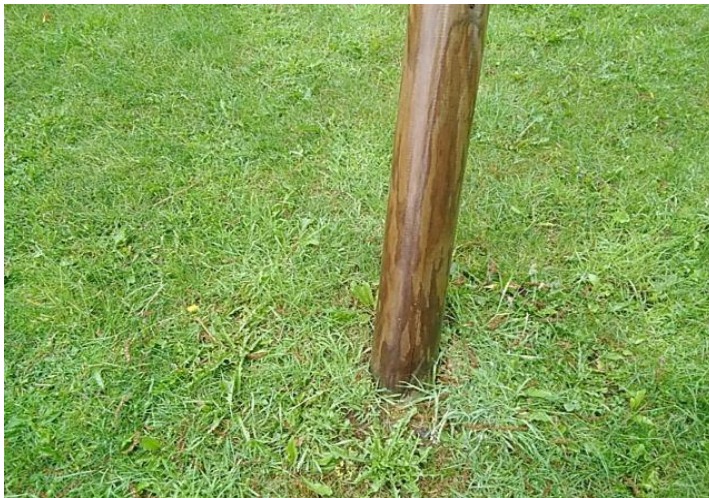
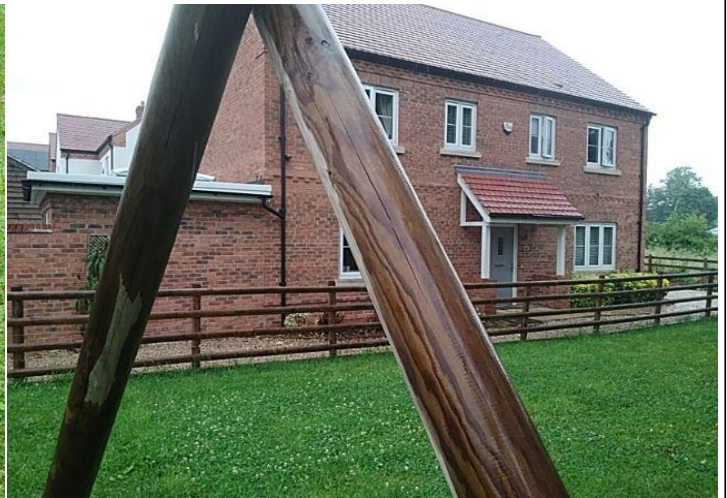
Item: Swings - 1 Bay Mixed Seat, 1 Cradle, 1 Flat
Manufacturer: Wicksteed Playgrounds

Finding: The timber has a number of splits/shakes or air cracks and this may affect the stability or allow water ingress which will accelerate the rotting process
Action: Monitor to ensure the splits do not cross through fixing points of the structure and/or cause any instability

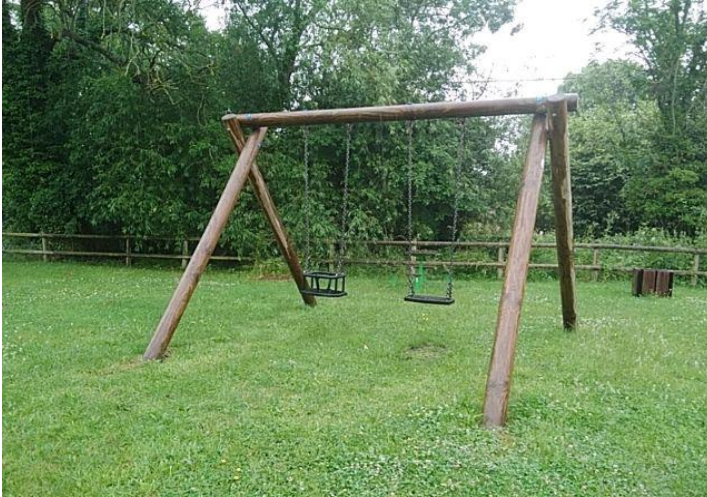
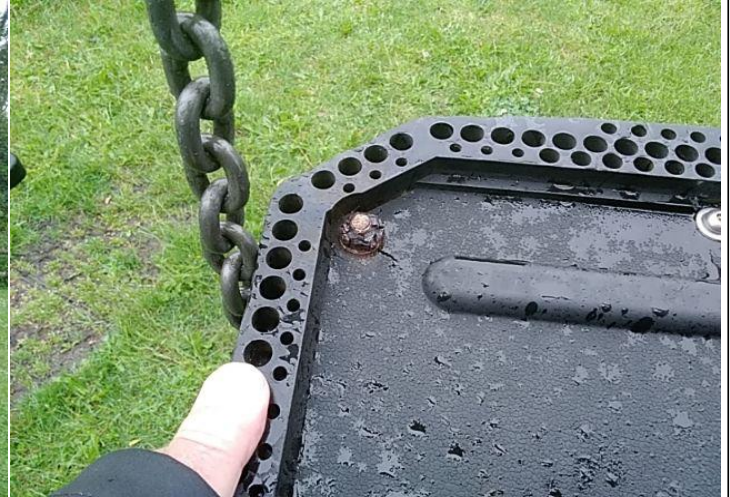
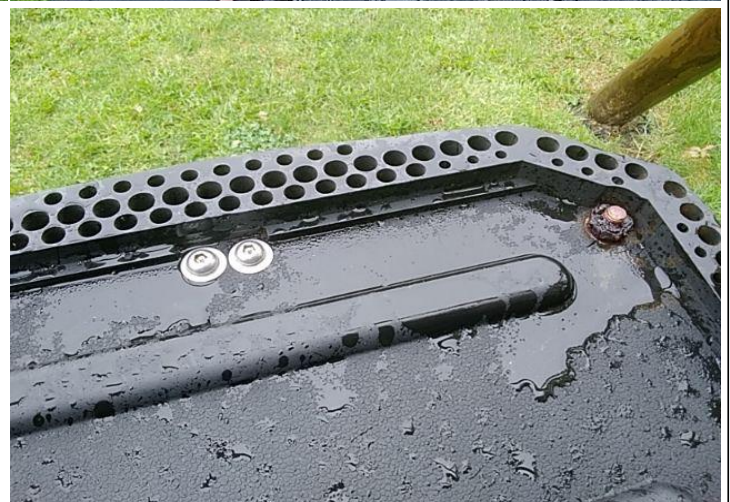
Item: Swings - 1 Bay Mixed Seat, 1 Cradle, 1 Flat
Manufacturer: Wicksteed Playgrounds

Finding: The cradle seat fixing nuts are corroding

Action: Monitor for deterioration and replace when required
