Annual Inspection

Osgathorpe Parish Council

Thomas Harley Play Area

off Dawson's Road, Osgathorpe, Loughborough,
Leicestershire, LE12 9SZ

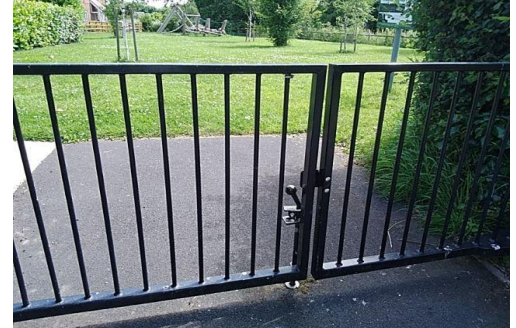
Item: Gate - Combination
Manufacturer: I.A.E. Fencing
Surface Type: Tarmac
Item Quantity: 1
Equipment Compliance: N/A
Surface Area Compliance: Yes

There is no padlock on the maintenance gate - Extend the ground so ket and provide a padlock to secure the gate

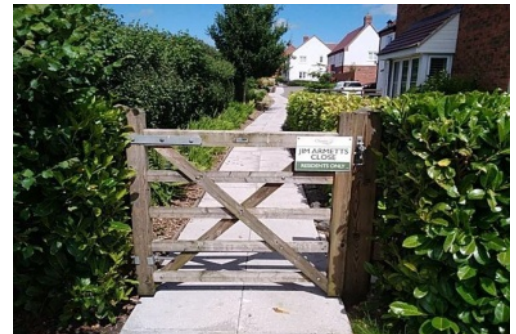
Item: Gate - Pedestrian
Manufacturer: Unknown
Surface Type: Paving Slabs
Item Quantity: 1
Equipment Compliance: N/A
Surface Area Compliance: Yes

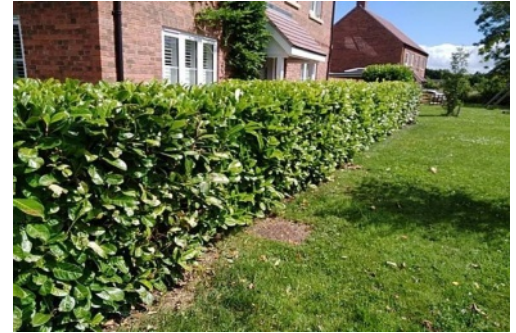
Item: Hedge
Manufacturer: Natural Feature
Surface Type: Grass
Item Quantity: 1
Equipment Compliance: N/A
Surface Area Compliance: N/A

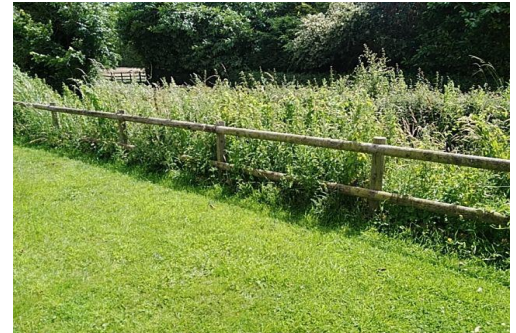
Item: Fencing - Post & Rail
Manufacturer: Unknown
Surface Type: Grass
Item Quantity: 1
Equipment Compliance: N/A
Surface Area Compliance: N/A

The timber has a number of splits/shakes or air cracks and this may affect the stability or allow water ingress which will accelerate the rotting process - Monitor to ensure the splits do not cross through fixing points of the structure and/or cause any instability

Intrusive bramble and nettle growth - Cut back and maintain as required

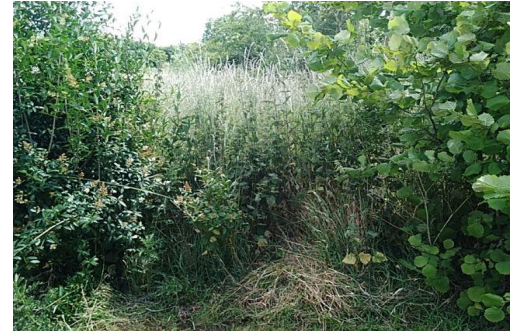
Item: Fence - Timber & Mesh Infill
Manufacturer: Unknown
Surface Type: Grass
Item Quantity: 1
Equipment Compliance: N/A
Surface Area Compliance: N/A

Weeds and nettle growth in the area - Cut back and maintain as required

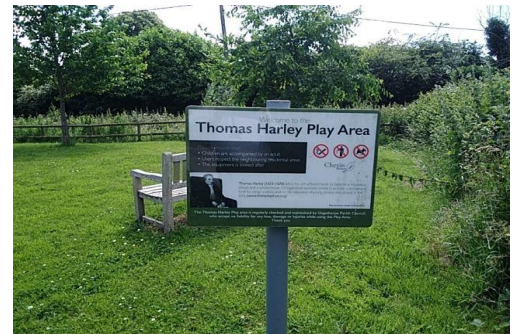
Item: Playground Sign
Manufacturer: Not Applicable
Surface Type: N/A
Item Quantity: 1
Equipment Compliance: N/A
Surface Area Compliance: N/A

It is recommended that signage, with information including the site address, contact information for maintenance issues and emergency contact details are provided for the facility - Provide in accordance with the recommendations

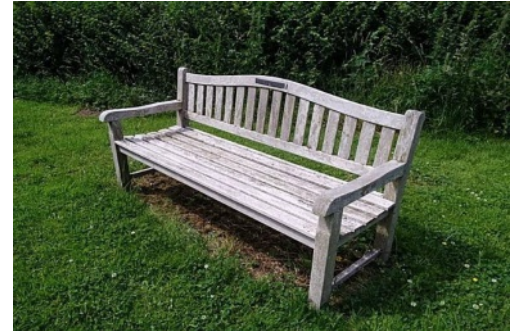
Item: Seat
Manufacturer: Unknown
Surface Type: Grass
Item Quantity: 1
Equipment Compliance: N/A
Surface Area Compliance: Yes

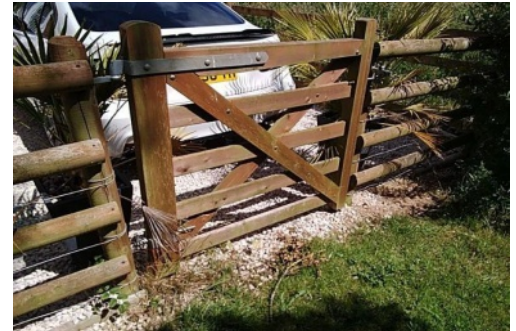
Item: Gate - Pedestrian
Manufacturer: Unknown
Surface Type: Mixed Surface
Item Quantity: 1
Equipment Compliance: N/A
Surface Area Compliance: Yes

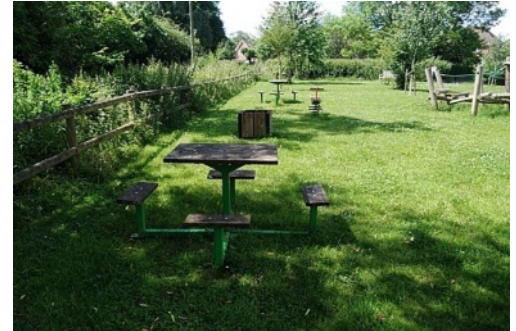
Item: Picnic Table
Manufacturer: Wicksteed Playgrounds
Surface Type: Grass
Item Part Number: Windsor Picnic Table
Item Quantity: 2
Equipment Compliance: N/A
Surface Area Compliance: Yes
Total Findings: 1

This item is satisfactory - no work required -

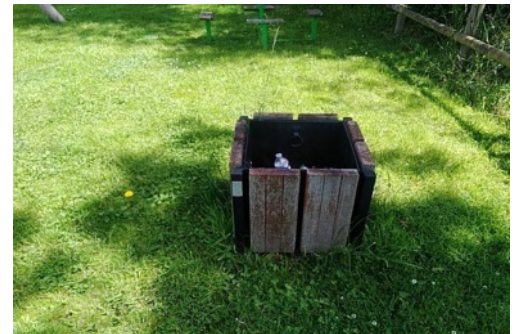
Item: Litter Bin
Manufacturer: Wicksteed Playgrounds
Surface Type: Grass
Item Part Number: Annick Wooden Bin
Item Quantity: 1
Equipment Compliance: N/A
Surface Area Compliance: Yes
Total Findings: 1

This item is satisfactory - no work required -

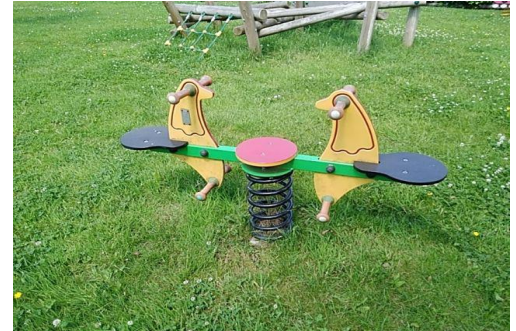
Item: Spring See-Saw
Manufacturer: Wicksteed Playgrounds
Surface Type: Grass Matrix Tiles
Item Part Number: Cockerel Spring Seesaw
Item Quantity: 1
Equipment Compliance: Yes
Surface Area Compliance: Yes
Total Findings: 1

The spring clamps are becoming loose - Monitor for deterioration and tighten all loose fixings when required

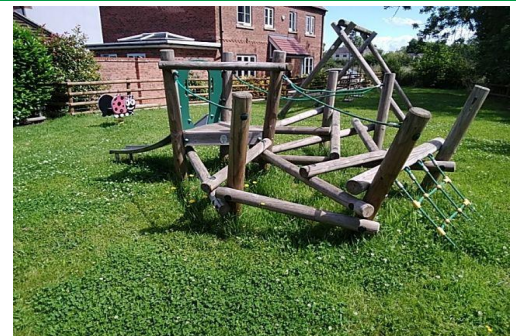
Item: Log Climber
Manufacturer: Wicksteed Playgrounds
Surface Type: Grass Matrix Tiles
Item Quantity: 1
Equipment Compliance: Yes
Surface Area Compliance: Yes

The timber has a number of splits/shakes or air cracks and this may affect the stability or allow water ingress which will accelerate the rotting process - Monitor to ensure the splits do not cross through fixing points of the structure and/or cause any instability

The grass is overgrown below the unit and may hide hazards - Reduce the length of grass to an acceptable height and maintain

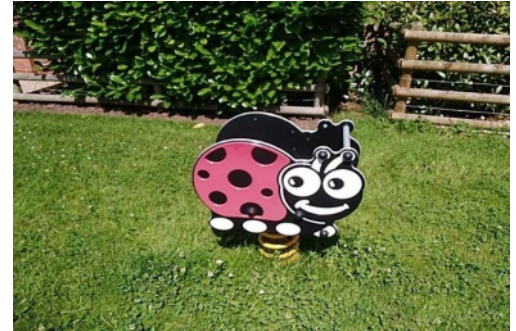
Item: Spring Ladybird
Manufacturer: Wicksteed Playgrounds
Surface Type: Grass Matrix Tiles
Item Quantity: 1
Equipment Compliance: Yes
Surface Area Compliance: Yes

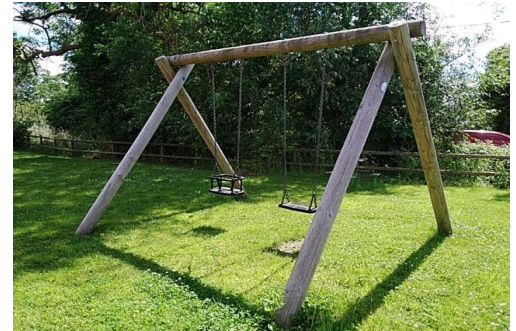
Item: 1 Bay Mixed Seat, 1 Cradle, 1 Flat
Manufacturer: Wicksteed Playgrounds
Surface Type: Grass Matrix Tiles
Item Part Number: 2.3m Timber Swing
Item Quantity: 1
Equipment Compliance: Yes
Surface Area Compliance: Yes
Total Findings: 2

The timber has a number of splits/shakes or air cracks and this may affect the stability or allow water ingress which will accelerate the rotting process - Monitor to ensure the splits do not cross through fixing points of the structure and/or cause any instability

The cradle seat fixing nuts are corroding - Monitor for deterioration and replace when required

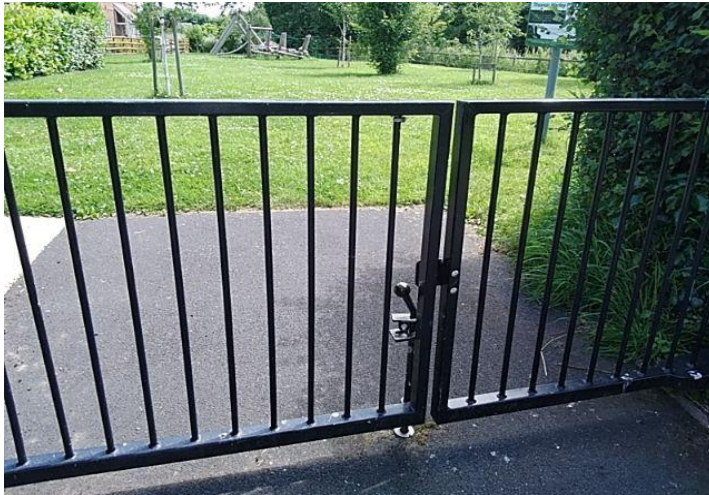
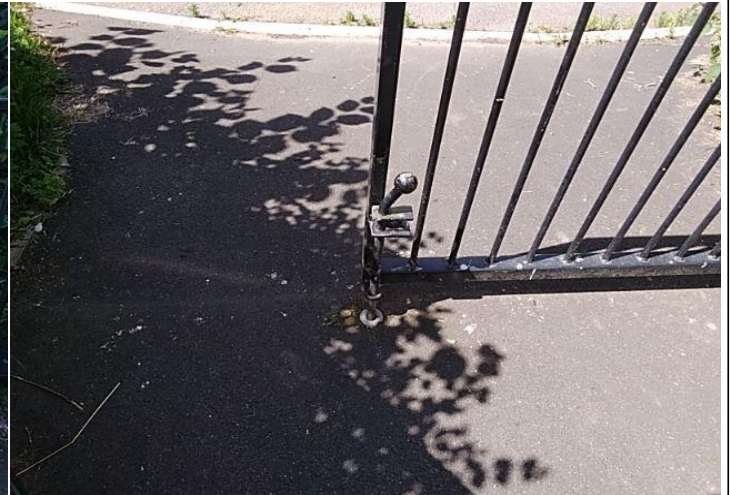
Item:	Gates - Gate - Combination	Risk Level:	L - Low Risk
Manufacturer:	I.A.E. Fencing	Surface:	Tarmac

Finding: There is no padlock on the maintenance gate

Action: Extend the ground so ket and provide a padlock to secure the gate

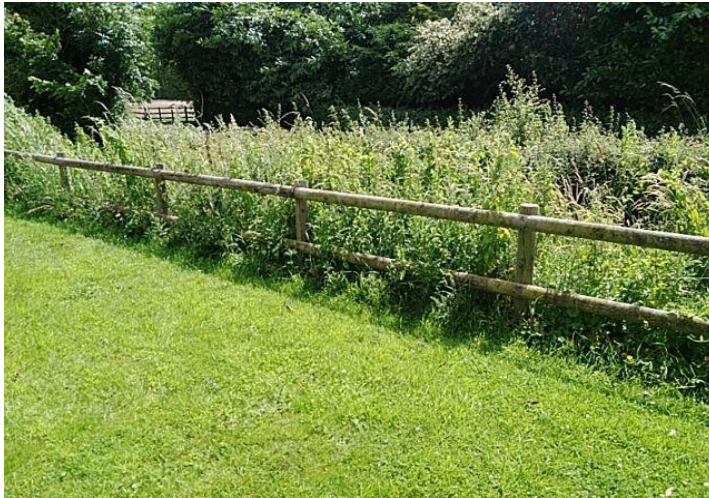
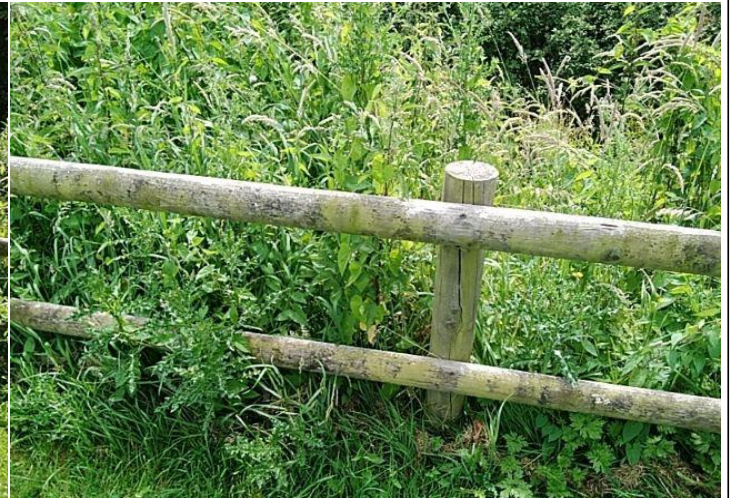
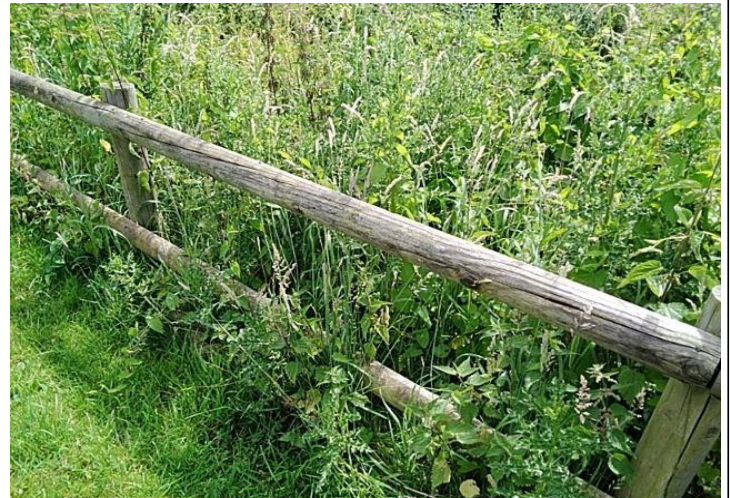
Item: Fences - Fencing - Post & Rail
Manufacturer: Unknown

Finding: The timber has a number of splits/shakes or air cracks and this may affect the stability or allow water ingress which will accelerate the rotting process

Action: Monitor to ensure the splits do not cross through fixing points of the structure and/or cause any instability

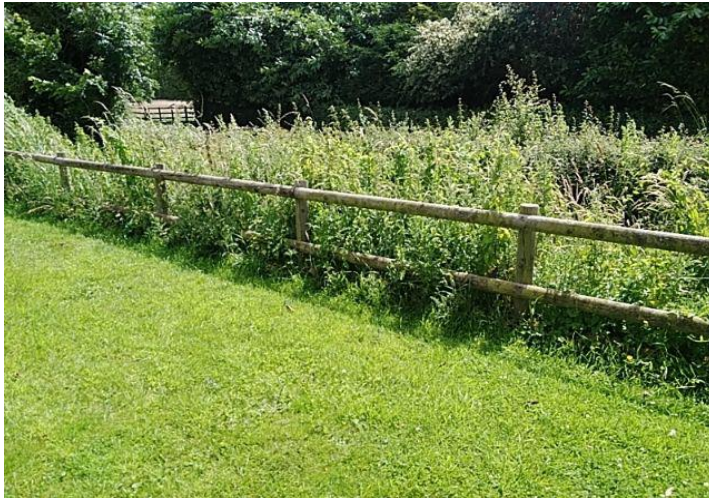
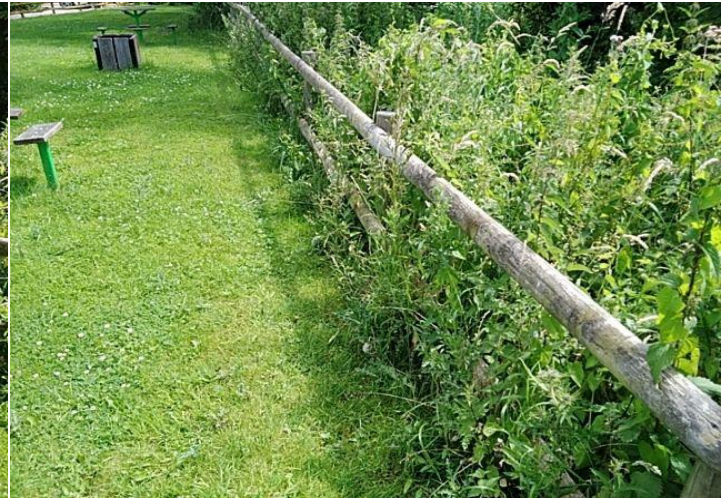
Item:	Fences - Fencing - Post & Rail	Risk Level:	V - Very Low Risk
Manufacturer:	Unknown	Surface:	Grass

Finding:	Intrusive bramble and nettle growth	Action:	Cut back and maintain as required
-----------------	-------------------------------------	----------------	-----------------------------------

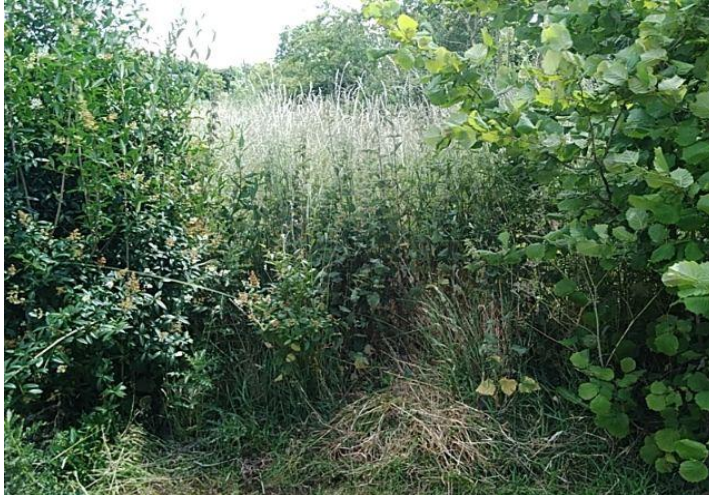
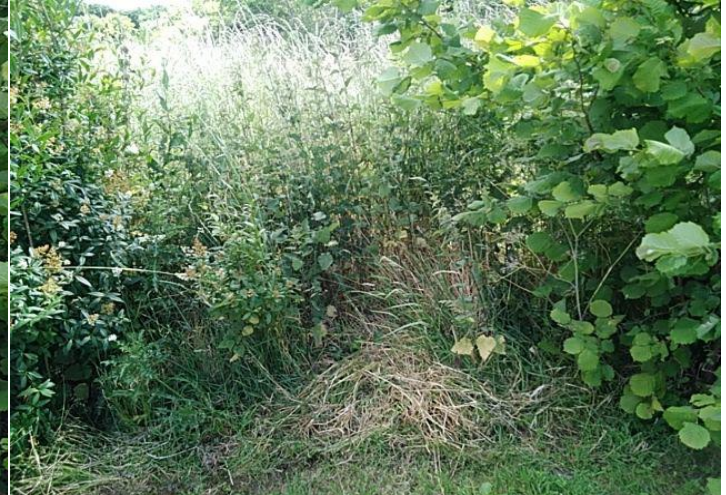
Item:	Fences - Fence - Timber & Mesh Infill	Risk Level:	V - Very Low Risk
Manufacturer:	Unknown	Surface:	Grass

Finding:	Weeds and nettle growth in the area	Action:	Cut back and maintain as required
-----------------	-------------------------------------	----------------	-----------------------------------

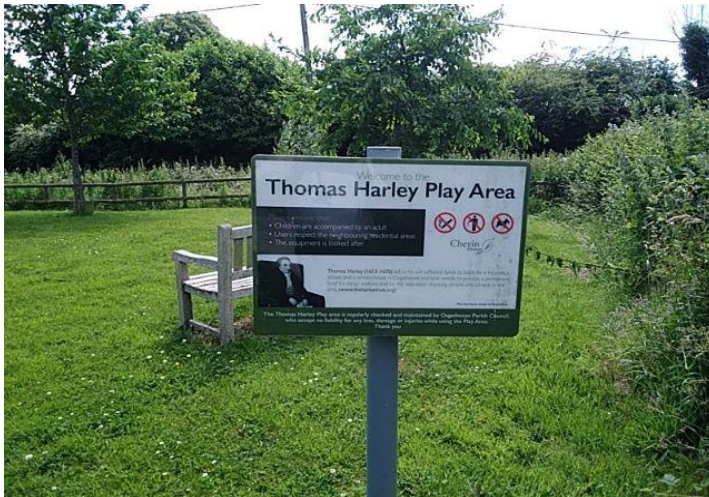
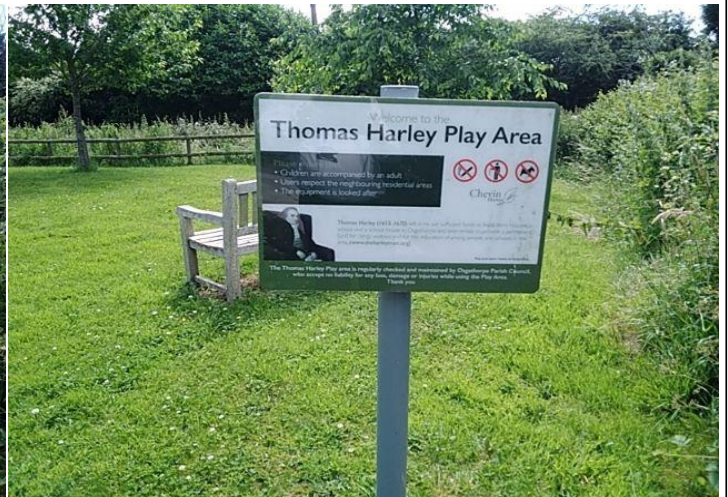
Item: Signs - Playground Sign
Manufacturer: Not Applicable

Finding: It is recommended that signage, with information including the site address, contact information for maintenance issues and emergency contact details are provided for the facility

Action: Provide in accordance with the recommendations

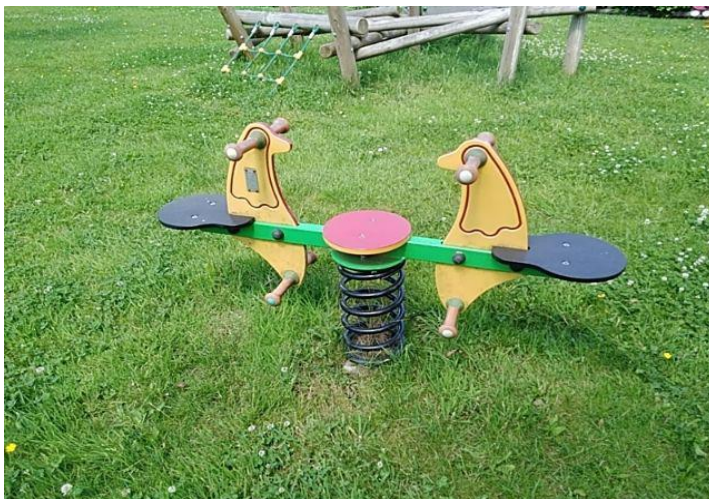
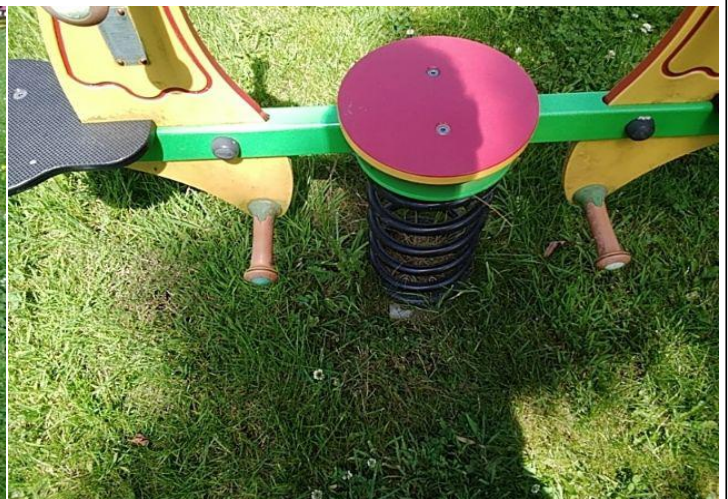
Item: Rocking Equipment - Spring See-Saw
Manufacturer: Wicksteed Playgrounds

Finding: The spring clamps are becoming loose

Action: Monitor for deterioration and tighten all loose fixings when required

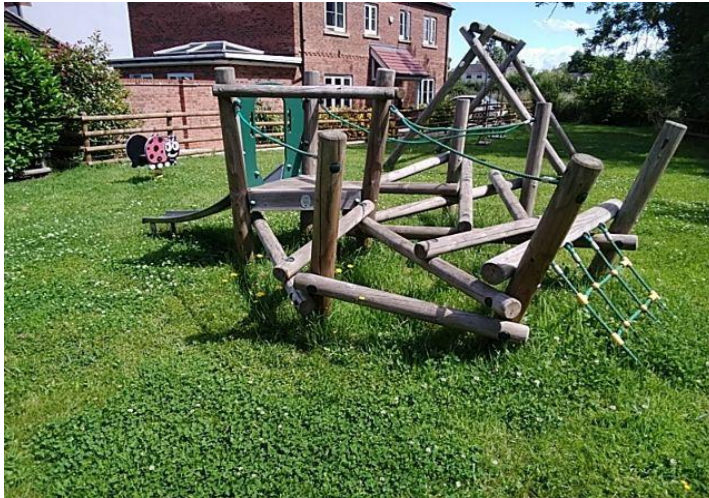
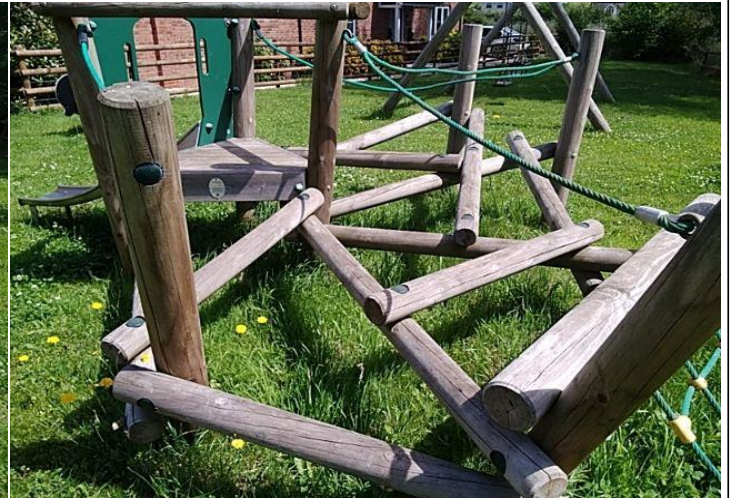
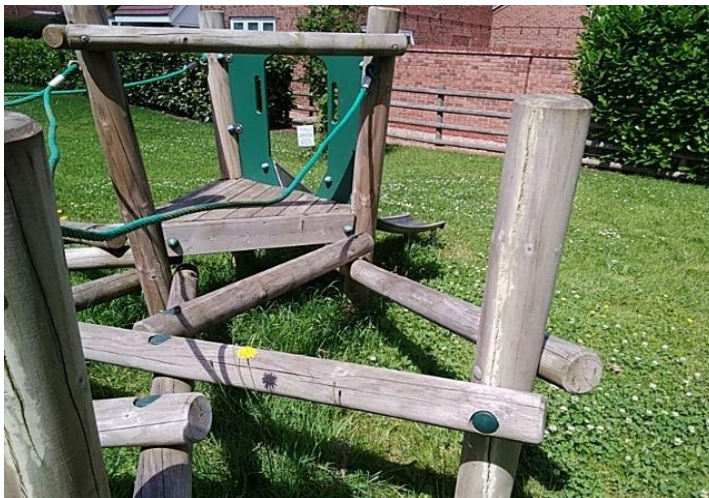
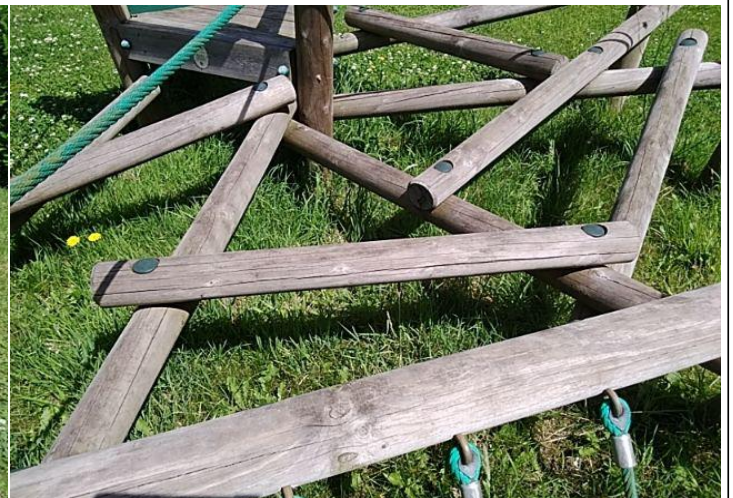
Item: Activity Equipment - Log Climber
Manufacturer: Wicksteed Playgrounds

Finding: The timber has a number of splits/shakes or air cracks and this may affect the stability or allow water ingress which will accelerate the rotting process
Action: Monitor to ensure the splits do not cross through fixing points of the structure and/or cause any instability

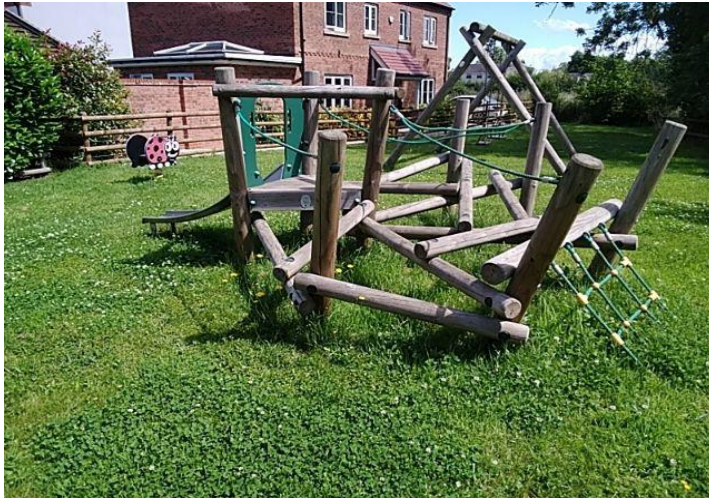
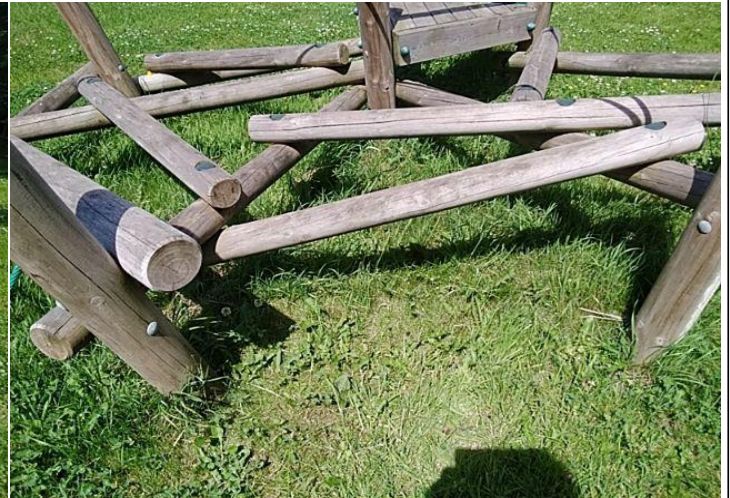
Item: Activity Equipment - Log Climber
Manufacturer: Wicksteed Playgrounds

Finding: The grass is overgrown below the unit and may hide hazards

Action: Reduce the length of grass to an acceptable height and maintain

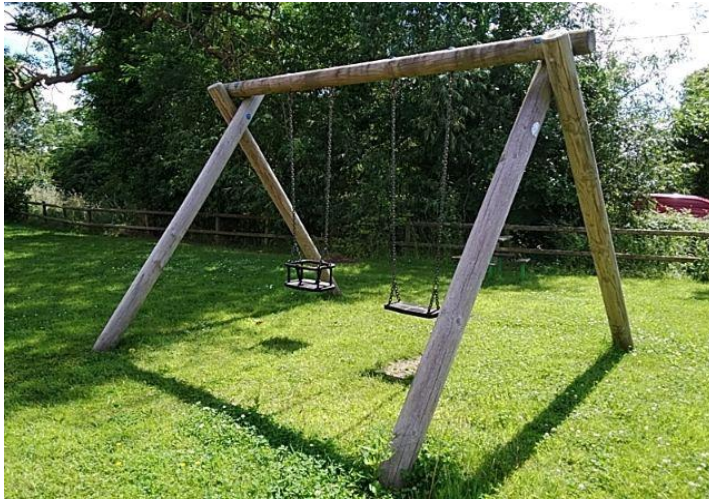
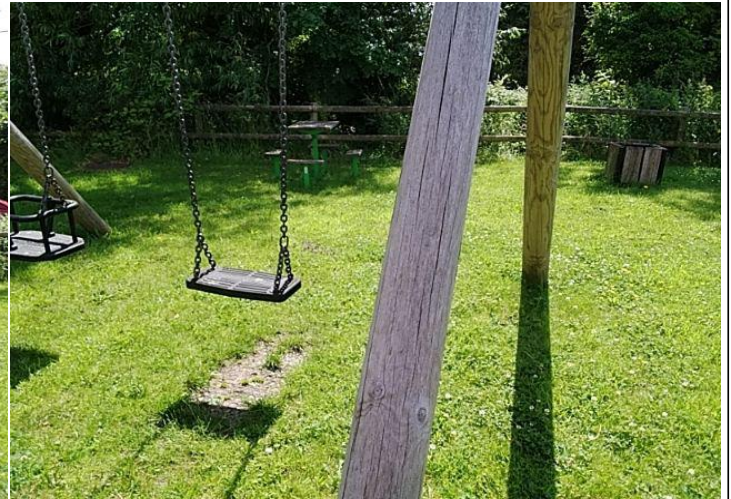
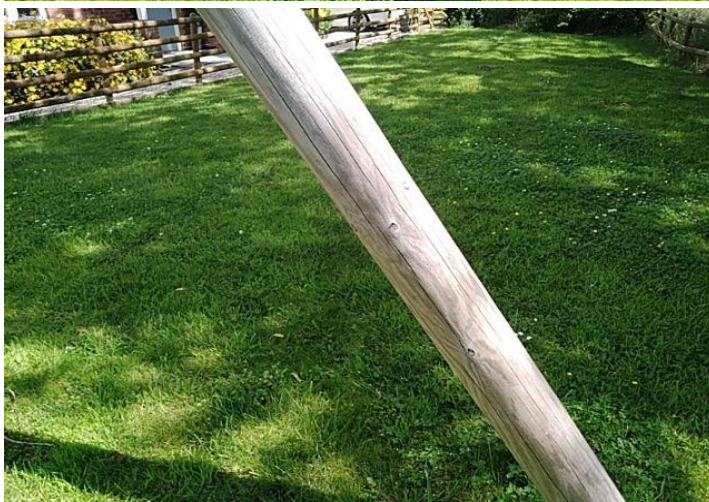
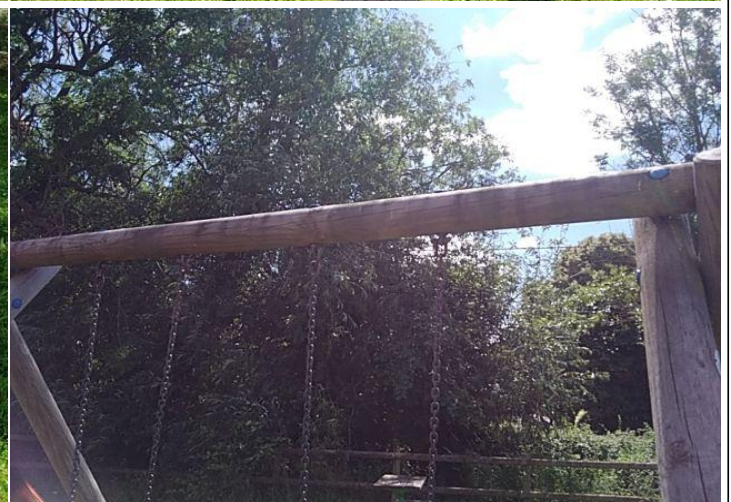
Item: Swings - 1 Bay Mixed Seat, 1 Cradle, 1 Flat

Finding: The timber has a number of splits/shakes or air cracks and this may affect the stability or allow water ingress which will accelerate the rotting process

Action: Monitor to ensure the splits do not cross through fixing points of the structure and/or cause any instability

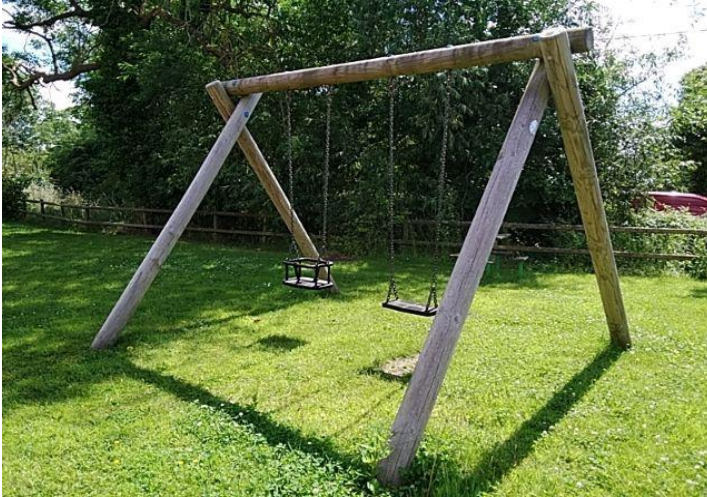
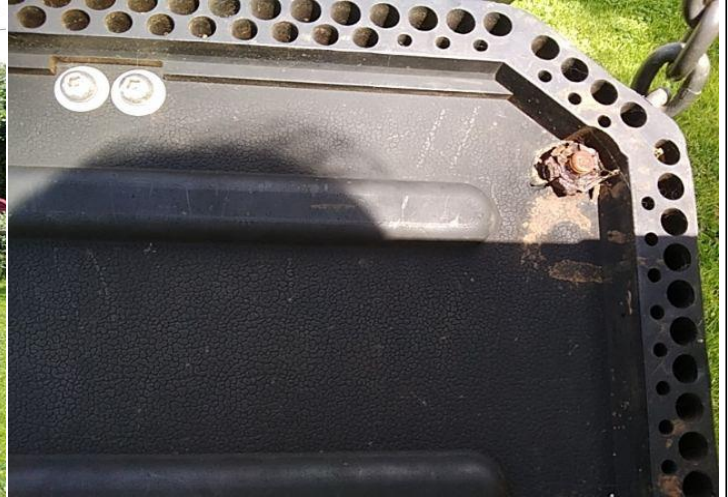
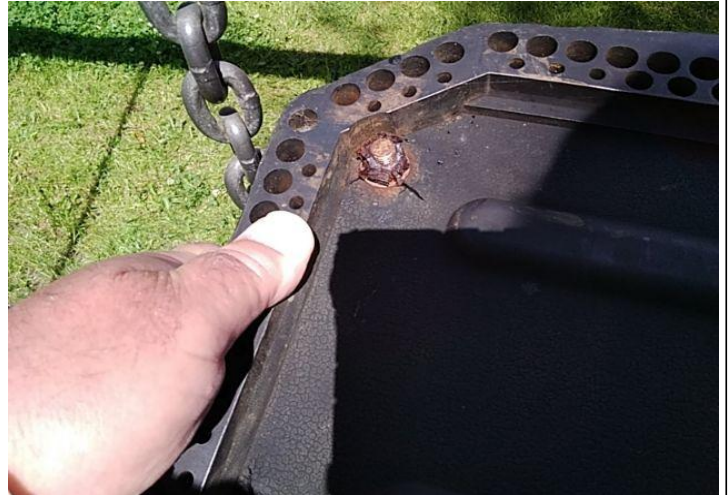
Item: Swings - 1 Bay Mixed Seat, 1 Cradle, 1 Flat
Manufacturer: Wicksteed Playgrounds

Finding: The cradle seat fixing nuts are corroding

Action: Monitor for deterioration and replace when required
